NIST Technical Note 1635

**A Case Study of a Community
Affected by the Witch and Guejito
Fires**

April 2009

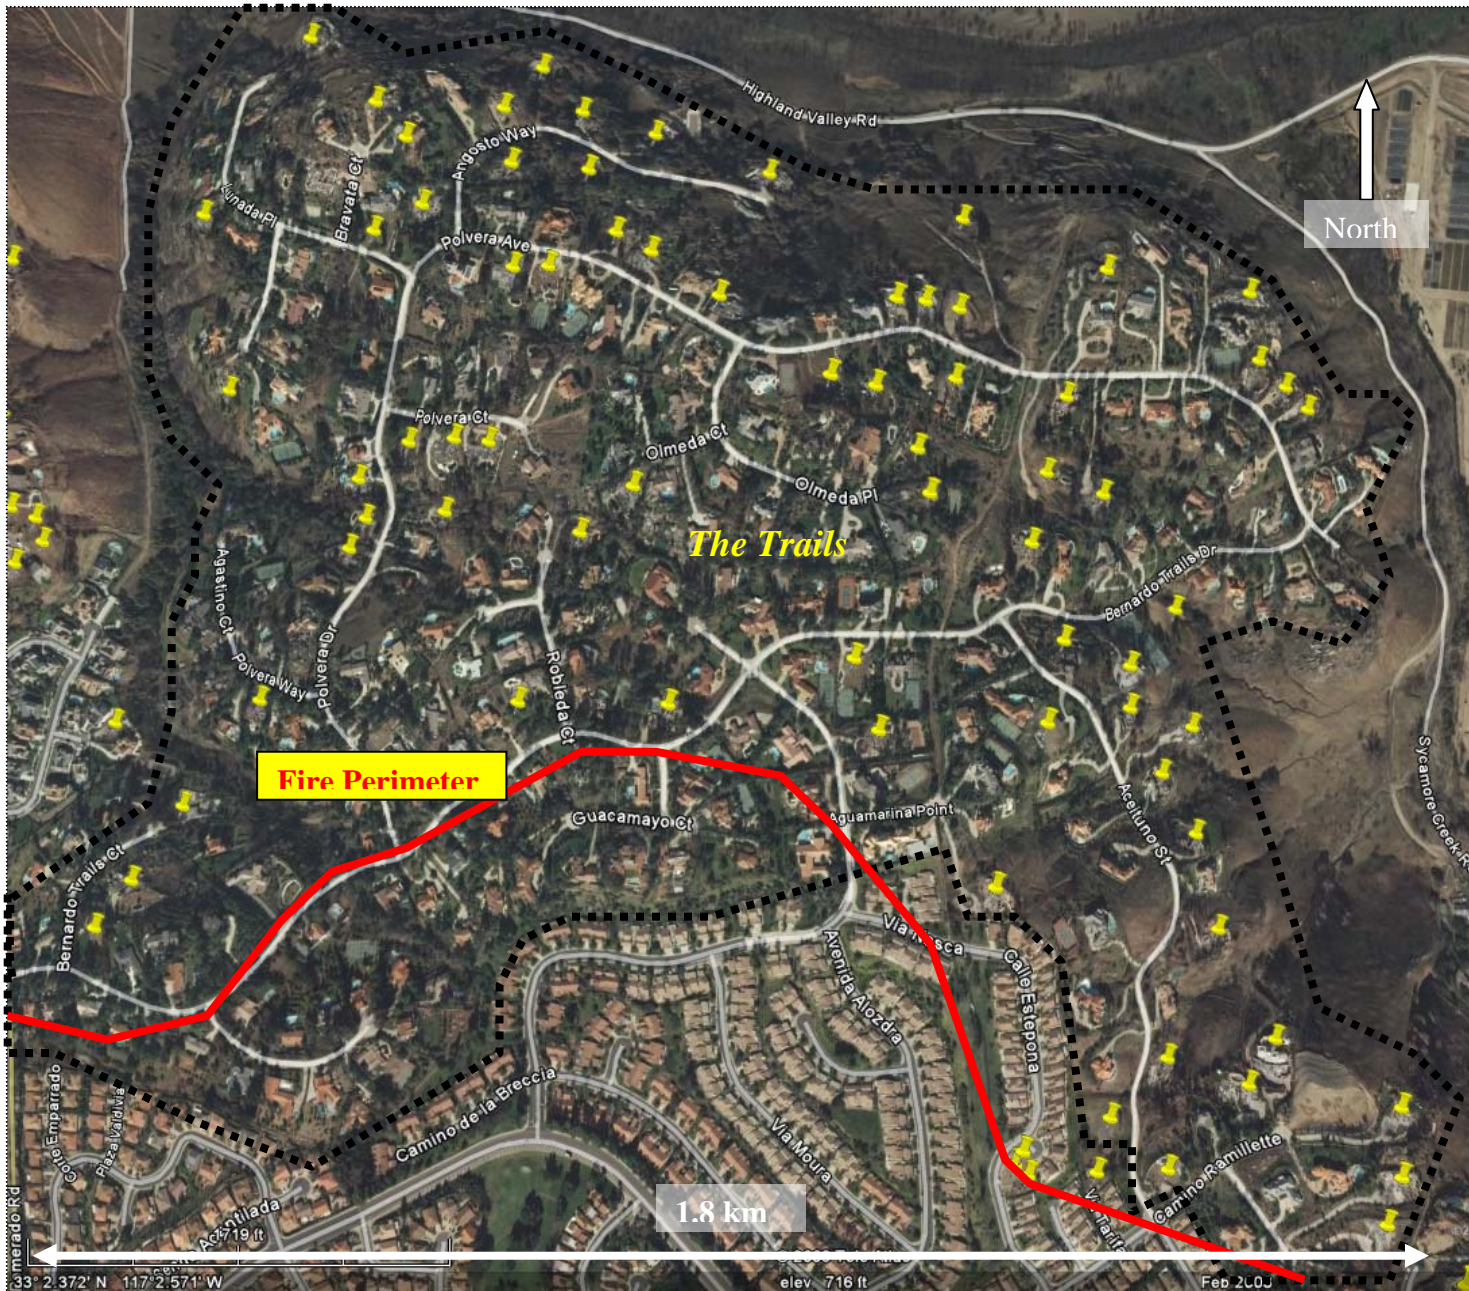
Figure 1: *The Trails* Community, Destroyed Homes (in Yellow) and Fire Perimeter after the Guejito and Witch Fires

The NIST WUI Team was invited by the California Department of Forestry and Fire Prevention (CAL FIRE) to collect post incident data from the California October 2007 fires. Early on, the NIST WUI Team initiated a case study within the Witch Fire perimeter. The case study is focused on The Trails development at Rancho Bernardo, 40 km (25 miles) north of the City of San Diego. There were 274 homes in The Trails, with 245 within the fire perimeter (Figure 1). Seventy four homes were completely destroyed and 16 were partly damaged.

445 feet). The community is 23 km (14 miles) east of the Pacific Ocean. The community consists of 283 residential lots (Figures 1 and 2). Although some lots on the perimeter of the community are larger, typical lots are approximately 6000 m² (1.5 acres). At the time of the fires there were 274 residences. Out of the 245 residences within the fire line, 74 were completely destroyed and an additional 16 sustained various degrees of damage. Housing density is approximately 116 homes per km² (300 homes per square mile). Figure 3 illustrates three different housing densities. The Trails is represented on the left, a community in Rancho Santa Fe, California is shown in the middle and a low density housing area is shown on the right. Note that the houses are not evenly distributed as the “density” becomes lower. The housing density within The Trails is greater than the densities seen outside of Rancho Bernardo but lower than the densities seen to the west of The Trails (Figure 2).

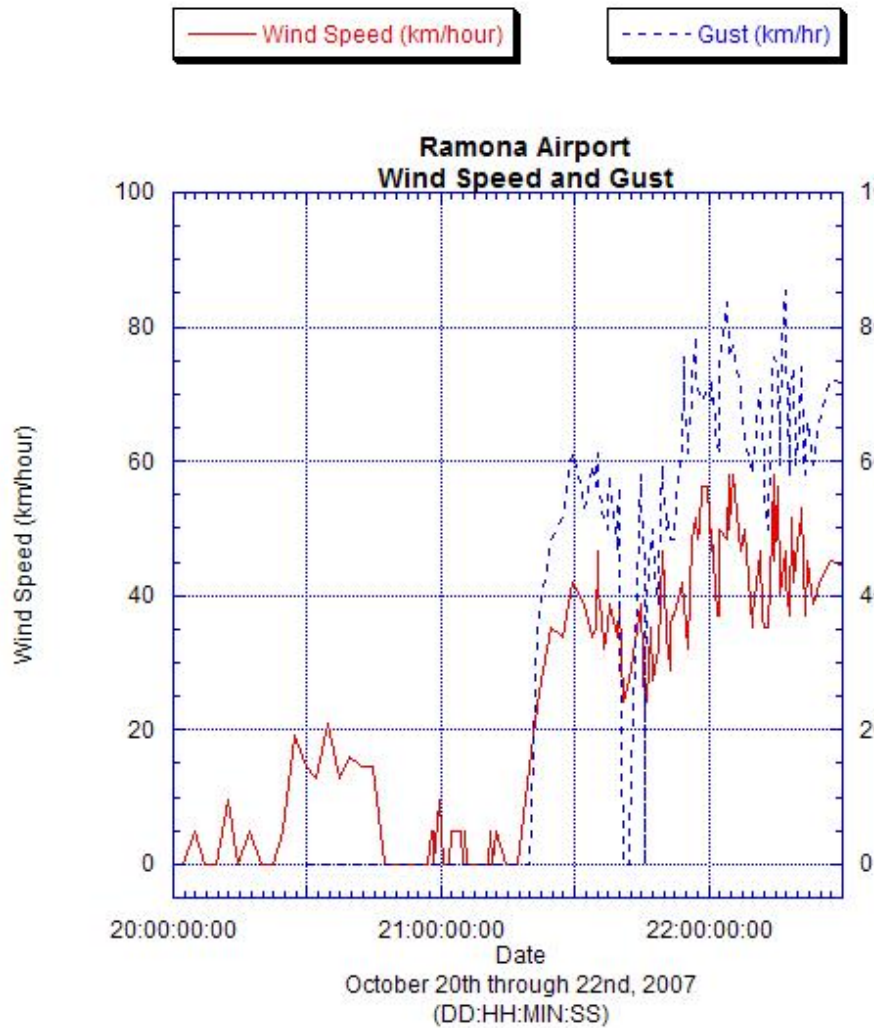
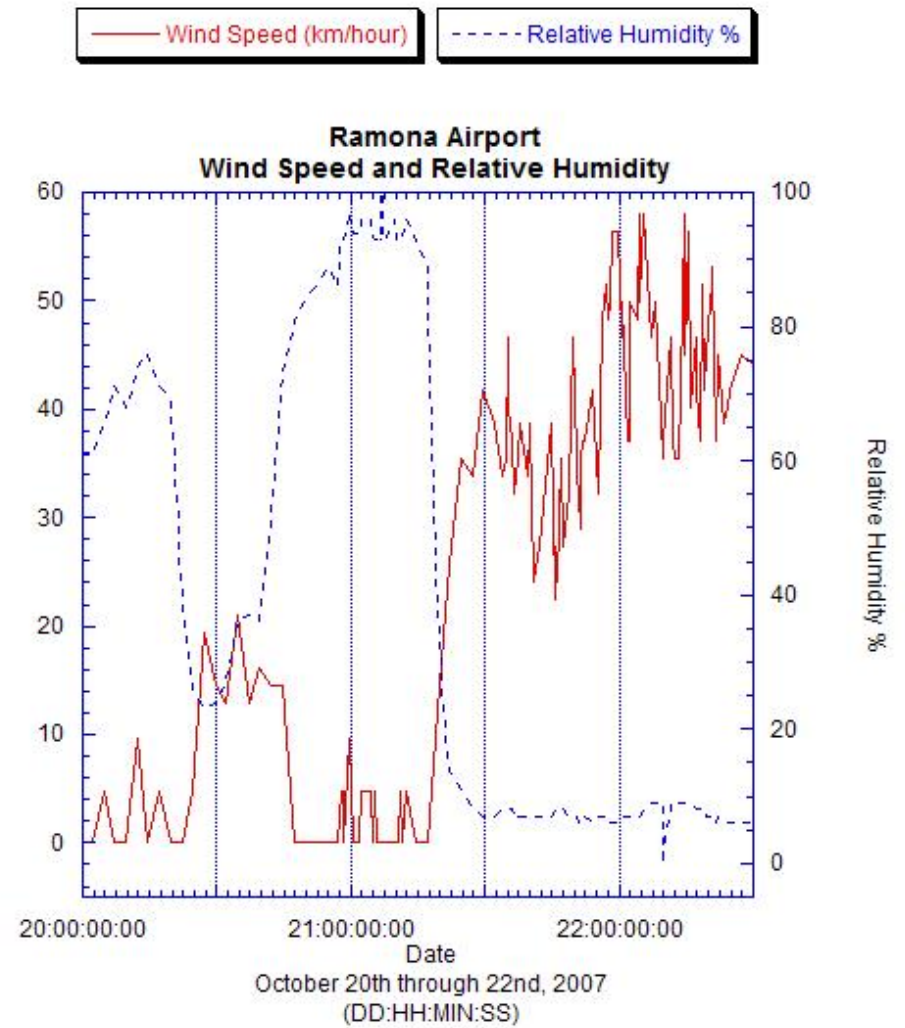
Figure 5: Weather data from Ramona Airport

The Ramona Airport weather station is 13 km due east from The Trails. The station recorded a dramatic drop in humidity while also recording a rapid increase in wind speed. Similar behaviors were recorded by the Poway NE1 station, located 10 km SSE of The Trails, and are summarized in Table 2. Figure 5 displays wind speed, wind gusts, wind direction and relative humidity at Ramona airport between October 20th and October 22nd.

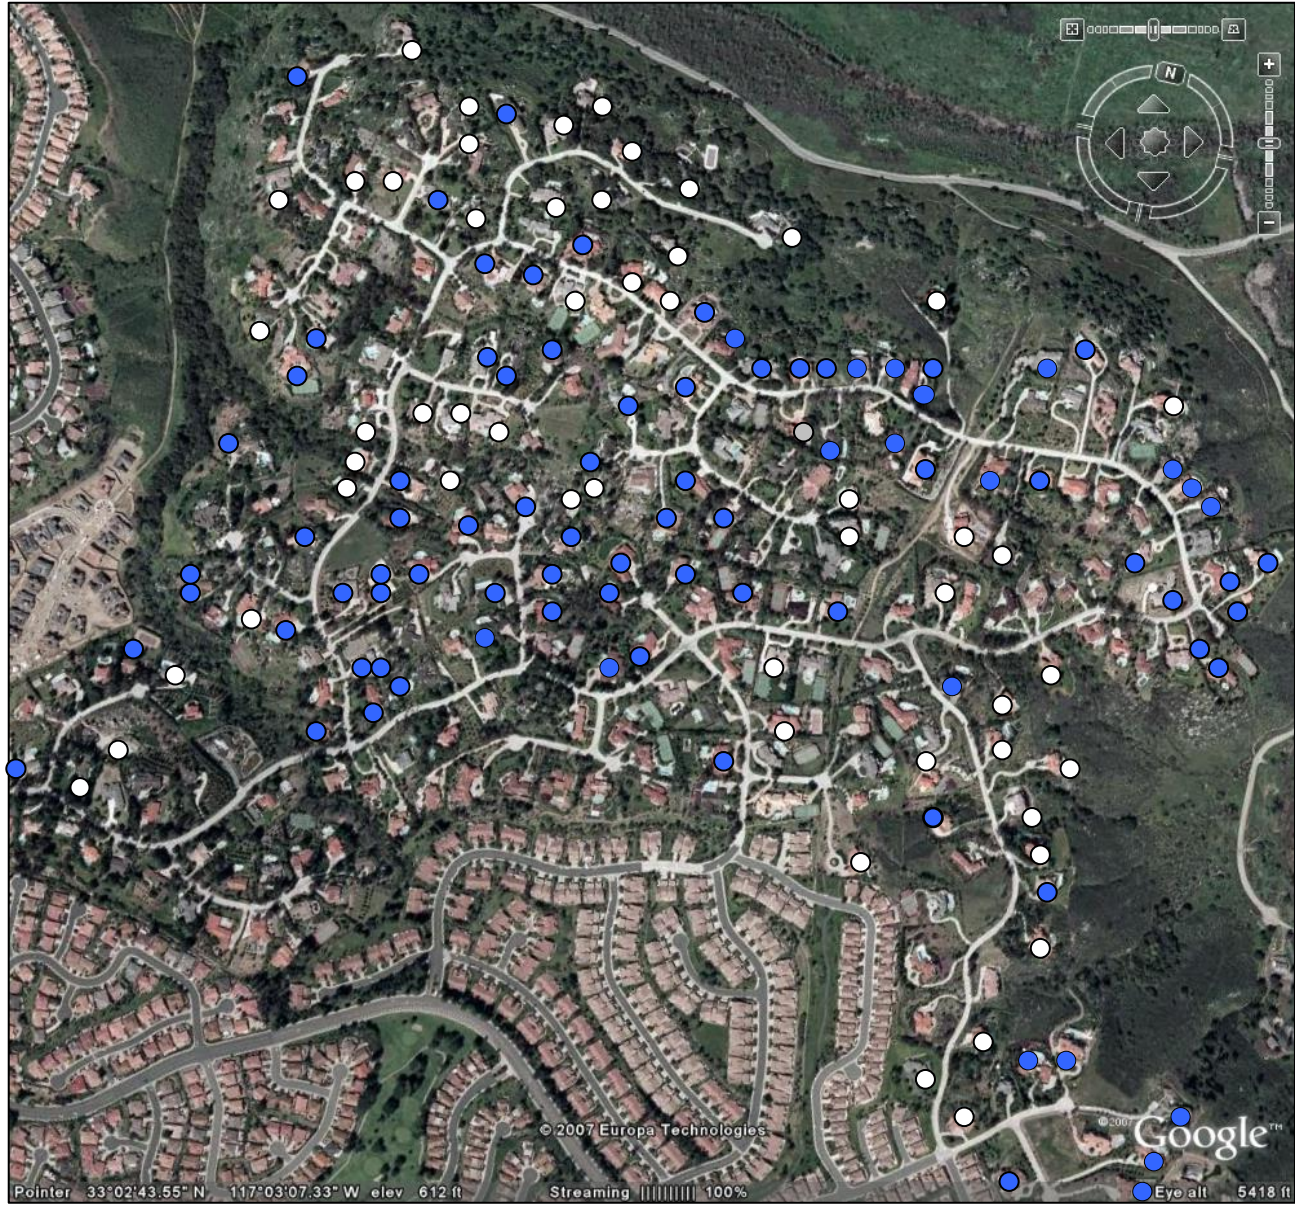
● (85) Defensive actions taken, including on 21 destroyed homes

○ (54) Destroyed home – unknown actions

Figure 22: The Trails Defensive Actions

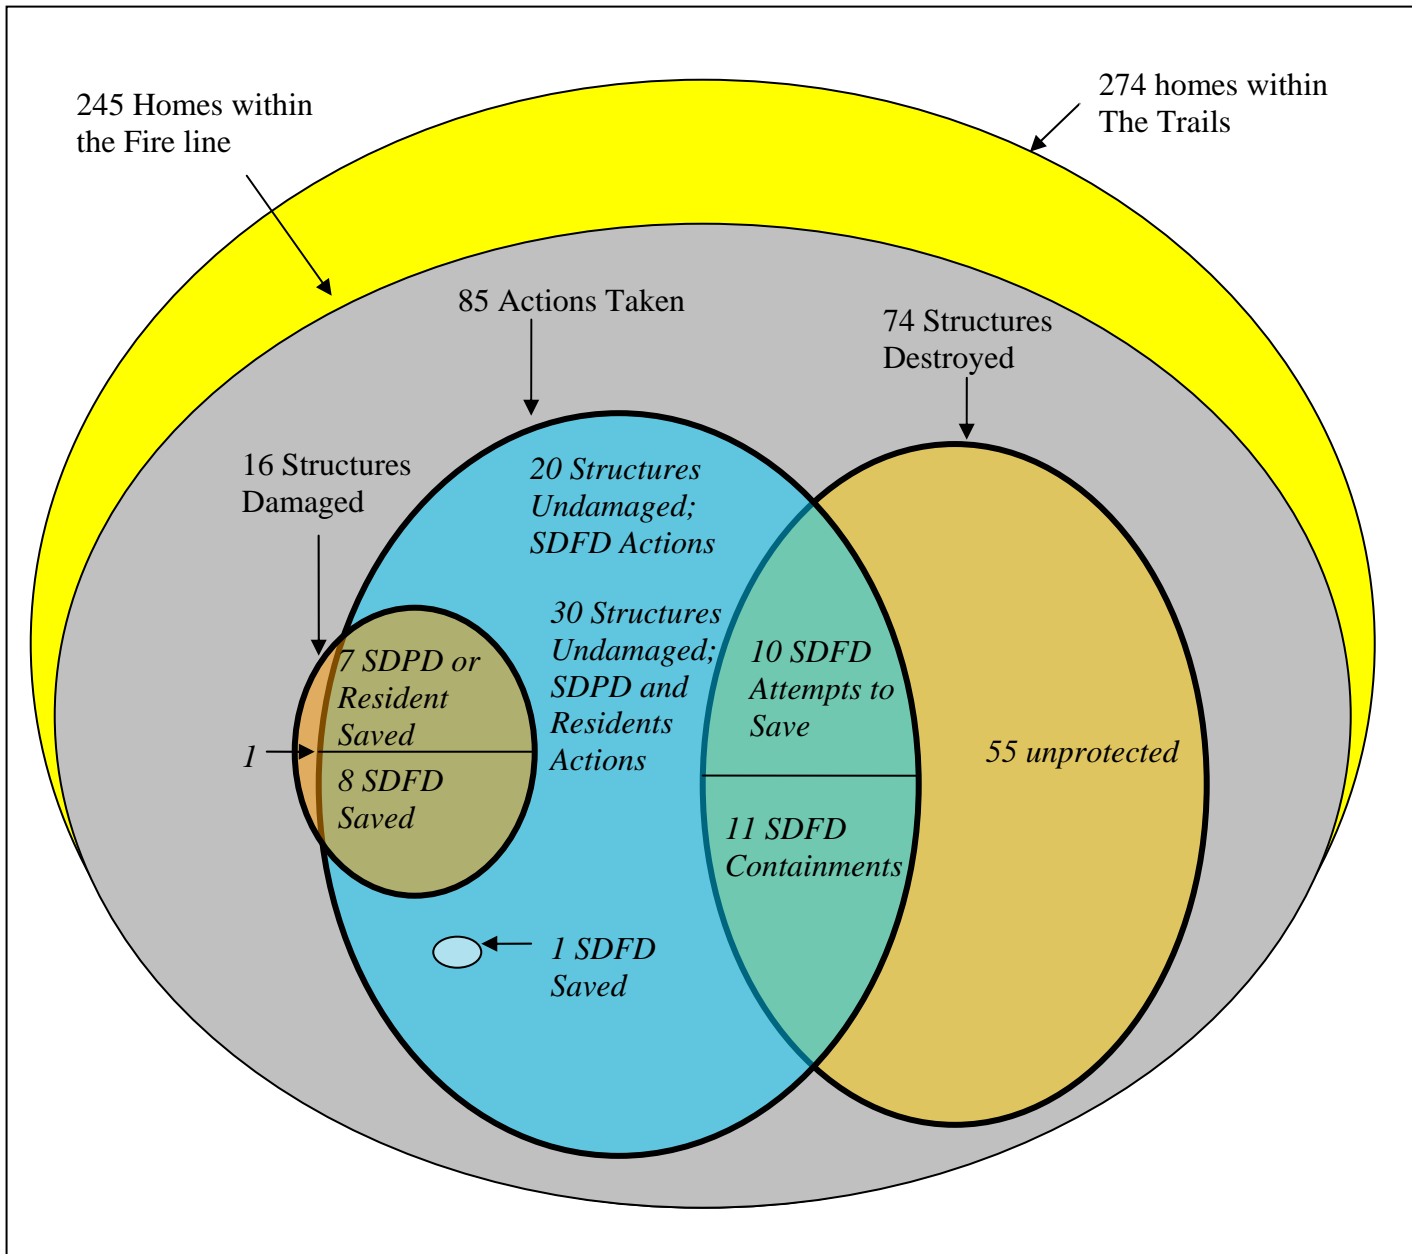
Figure 23: Impacts of the Defensive Actions Taken at The Trails

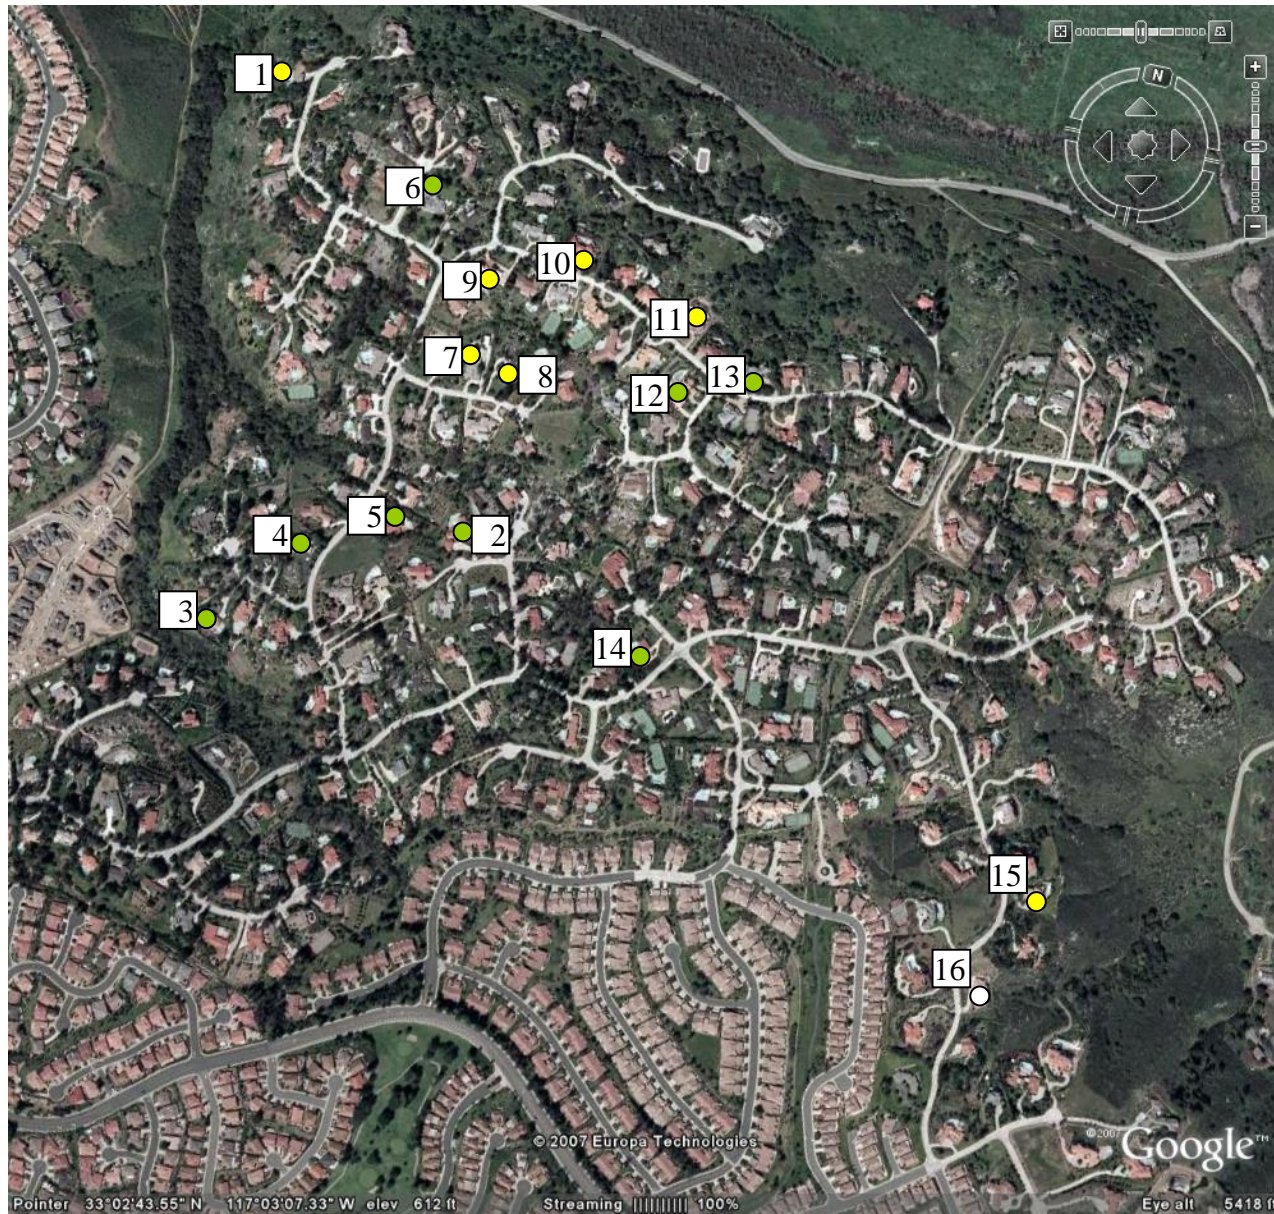
Damaged structure – SD FD defensive action taken (8)

Damaged structure – defensive action taken (7)

Damaged structure – no known action (1)

Figure 24: Damaged Structures. See Table 6 for further information on each house according to number on figure.

Identified defensive actions were taken on 15 out of the 16 homes. Table 6 lists type of damages and the time, if known, and type of detailed defensive action taken. Out of the fifteen defended structures, eight were defended by SDFD and five by residents or SDPD. For one damaged structure no defensive actions has been reported to date. Four out of the fourteen defensive actions occurred before 6:00 am, while the remaining seven occurred after 8 am, and the times for two defensive actions have not been identified. Figure 24 contains the locations of the damaged homes; numbers on Figure 24 correspond to House Number in Table 6.

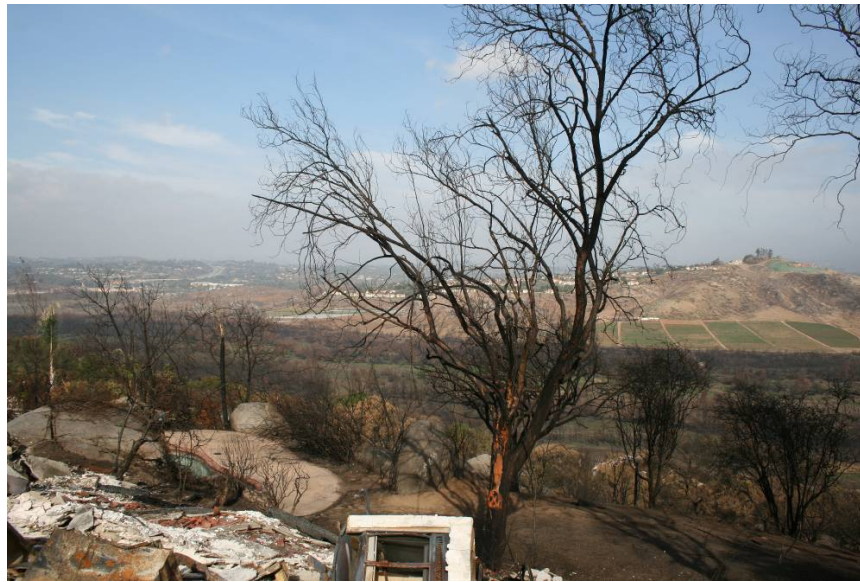
Figure 26: Structure Ignition Category A Fire from the wildlands burns uninterrupted up to the structure

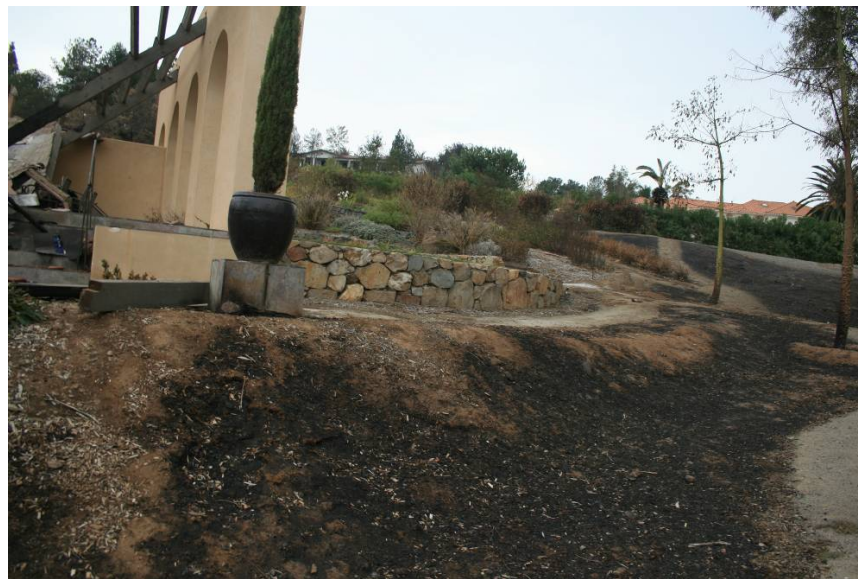
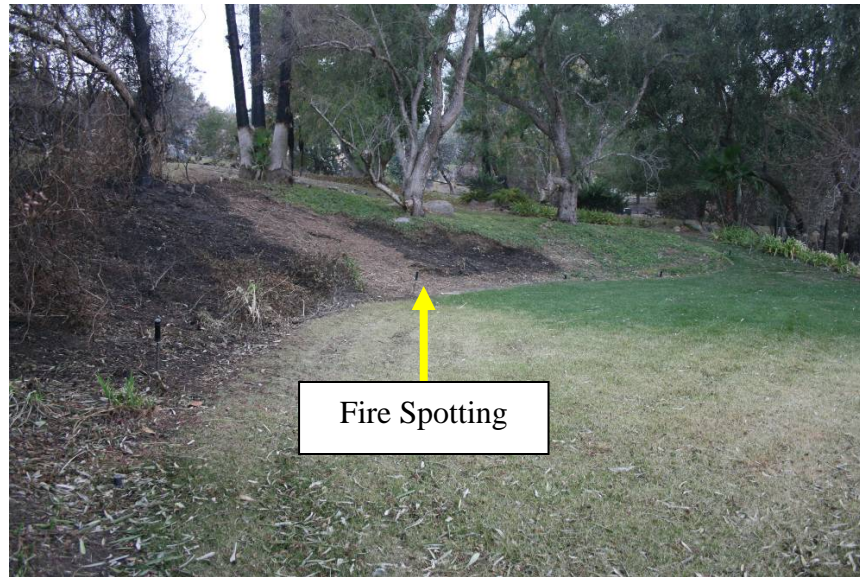
Figure 27: Structure Ignition Category B

Fire spotted to vegetation next to structure and possibly onto structure
